Manhole Inspection Summary

Manhole # S29I__012MH

Location Address: **W Pratt**

Cross Street: **MLK**

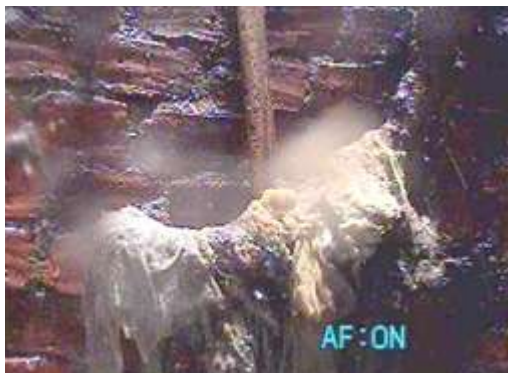
Defect 5

☒ **Evidence Of Surcharge** Depth: **4** (ft.) ☐ Active Surcharge Present

surcharge

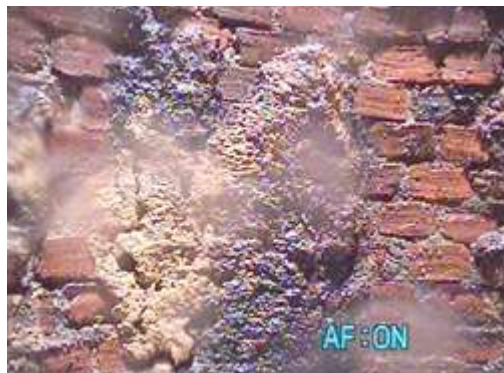
Defect 4

Condition: ☐ Sound ☐ Cracked ☐ Root Intrusion ☐ Loose Brick ☒ **Deteriorated**

Infiltration: ☐ None ☐ Joint ☐ Cracks ☐ Mortar ☐ Roots ☒ **Wall**

barrel wall infiltration and barrel deteriorated

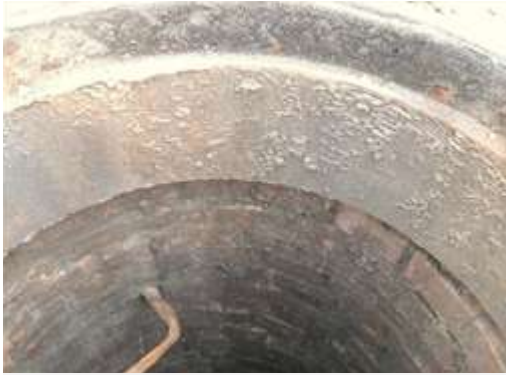
Defect 3

Condition: ☐ Sound ☐ Cracked ☒ **Leaks**

lid frame infiltration

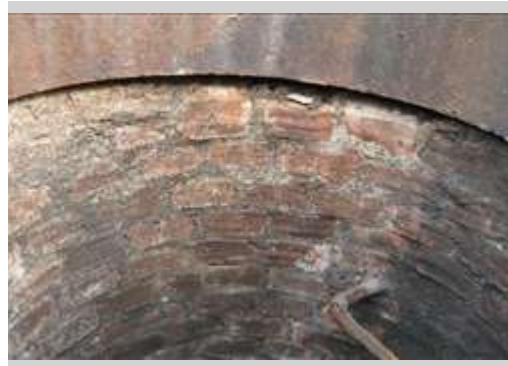
Defect 2

Condition: ☐ Sound ☐ Cracked ☐ Root Intrusion ☒ **Loose Brick** ☐ Deteriorated

Infiltration: ☐ None ☒ **Joint** ☐ Cracks ☐ Mortar ☐ Roots ☐ Wall

chimney has loose brick with infiltration coming from gap in joint between chimney and frame

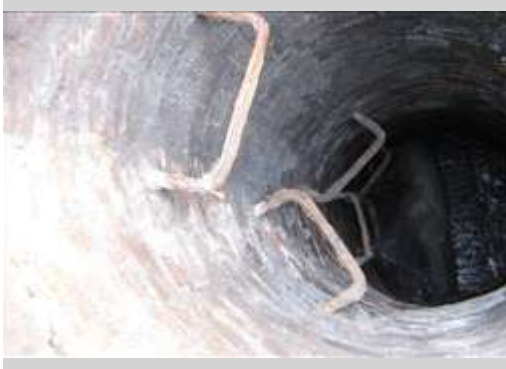
Defect 1

Count: **9** Missing: **0** ☒ **Corroded**

corroded rungs

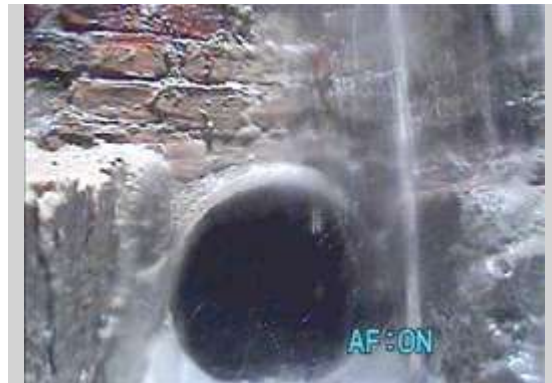
Drop In @ 6 O'Clock

Drop: **Inside** Rod and Bar
Angled: **Yes** Reading: **13.30** (ft.)
Inv Depth: **14.30** (ft.)
Drop Condition: **Clogged**

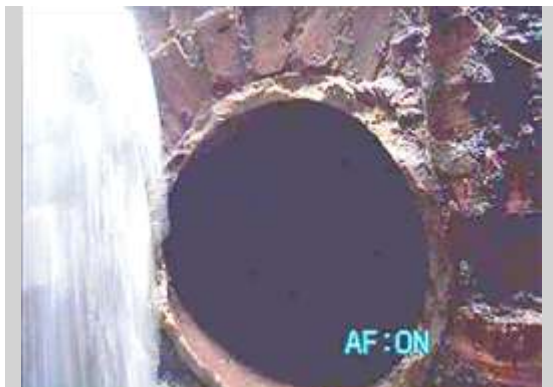
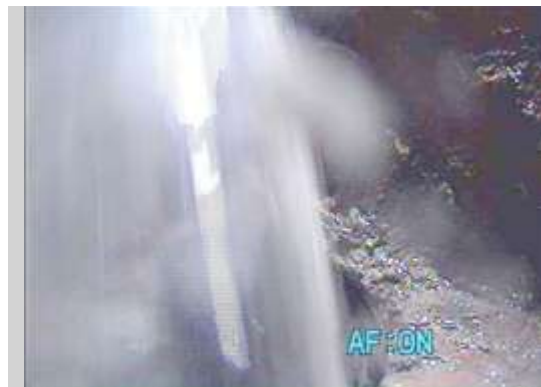
Drop In @ 8 OClock

connection obscured by flow from pipe in
connection @ 6 oclock
